RCRA Compliance Inspection Report

U.S. Department of Energy Hanford

242-A Evaporator, 616 Area, and 222-S Laboratory

September 22-24, 2014

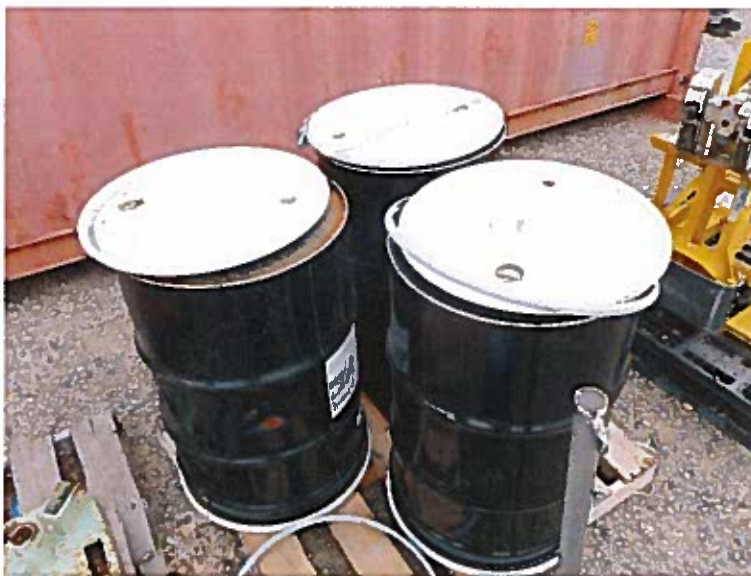
Photo P1010596. Discarded drums at 616 area

In the outdoor area at the 616 Area, I observed a few empty drums. Mr. Triner explained that the drums had been removed from service because they had rust spots on them. Because of issues with rusty containers holding waste at the Central Waste Complex (CWC) that were identified during an April 1, 2014 inspection, I took a close look at these drums (Photo P1010596). I observed that the drums that had been deemed unfit for use and removed from service by WRPS appeared to me to have significantly less rust on them and were in much better condition than the rusty drums being used to store waste at the CWC which is managed by CH2MHill Plateau Restoration Company (CHPRC).

- P1010596 – View of unused drums located outside the 616 building. The facility explained that these drums were taken out of service because they had started to rust.

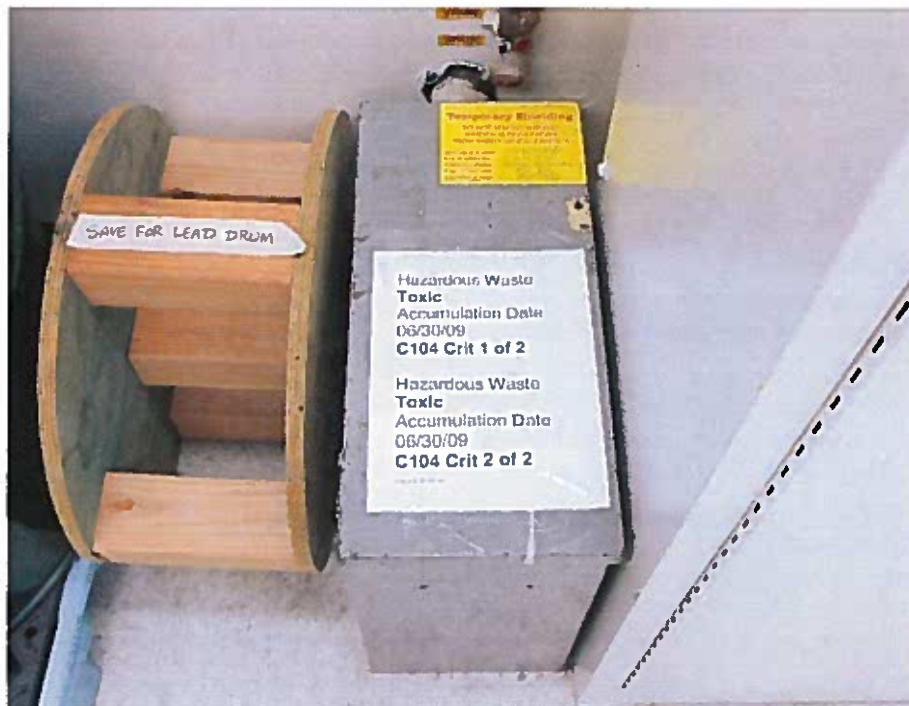
PIC 22. Container of TRU waste .

In the Room 4-E storage unit in the 222-S Building, I observed a 2ft x 1ft x 2ft rectangular metal container. The container was labeled as "hazardous waste-toxic" and had a start date marked on it of 6/30/09 (photo PIC 22). Mr. McKarns explained that this waste was transuranic (TRU) waste and was in storage for well over the one year limit established by the land disposal restriction regulations (LDR) in 40 C.F.R. § 268.50 (which is incorporated by reference at WAC 173-303-140(2)(a)), because the only place that is allowed to dispose of or permanently store TRU waste is the Waste Isolation Pilot Project (WIPP) facility in New Mexico. Mr. McKarns said that the WIPP facility is currently shut down for repairs and will likely not reopen to accept waste until early 2016. According to information I found at <http://www.wipp.energy.gov/wipprecovery/recovery.htm>, the WIPP operations were shut down following an underground truck fire and radiological release in February 2014. A recovery plan was issued on September 30, 2014 that outlines the necessary steps to resume limited waste disposal operations in the first quarter of calendar year 2016. Mr. McKarns provided me no additional information during the inspection that indicated why this container of mixed waste was not sent to the WIPP by June 2010 or that the extended storage of this waste was solely for the purpose of accumulation of such quantities to facilitate proper recovery, treatment or disposal.

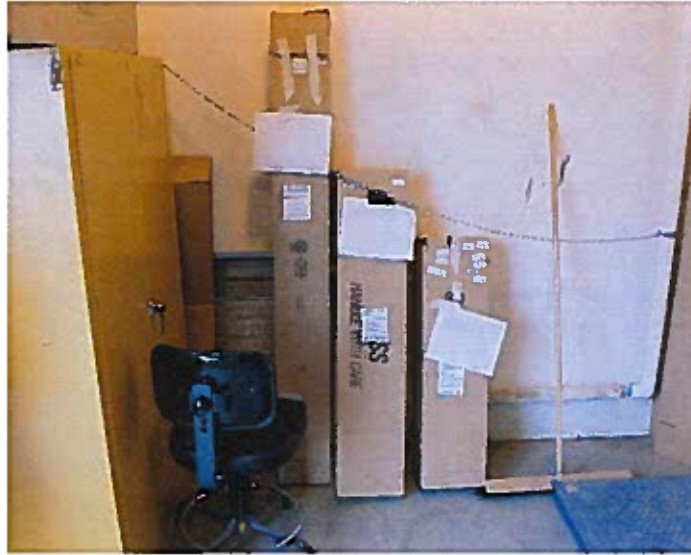
PIC 15. Boxes of universal waste lamps after label was attached to the box on the left.

During the tour of the 222-S Laboratory Universal Waste accumulation area in Building 2716-S, I observed a rectangular cardboard box which facility personnel said contained 8ft long fluorescent lamps being managed as universal waste (photo PIC 15). I noticed that the box had a log sheet on it that Ms Borneman said was used to record the date that universal waste lamps were added to the box. According to the log sheet, the box contained six fluorescent lamps that had been placed in it on August 25, 2014. I inspected the entire box and did not see any marking on it that indicated the lamps in the box were Universal Waste. Next to this box of lamps, I observed two other boxes of lamps that were labeled as universal waste lamps. I pointed out the lack of a universal waste label or other marking on the first box I observed and one of the facility staff people immediately placed a label on it that read "Universal Waste (Lamps)."
